Re: Health & Safety Compliance Audit

Address Visited: Sandy Point, Hayling Island, Hampshire, PO11 9SL

Appointment Date: 28 January 2025

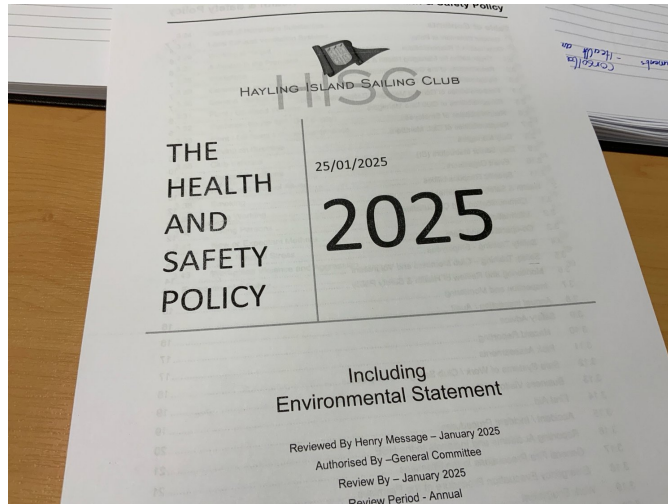
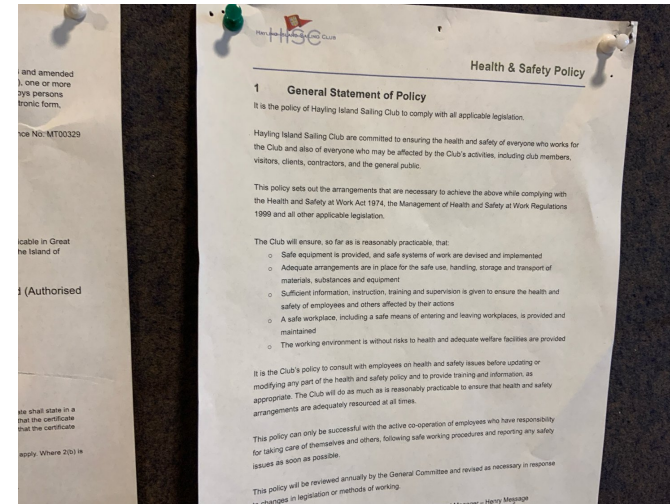
The health and safety policy is current, signed by the overall responsible person and readily available. Documentary Evidence Seen - 06 January 2026 Please refer to image(s) under item 1.1 in the Photographs section.

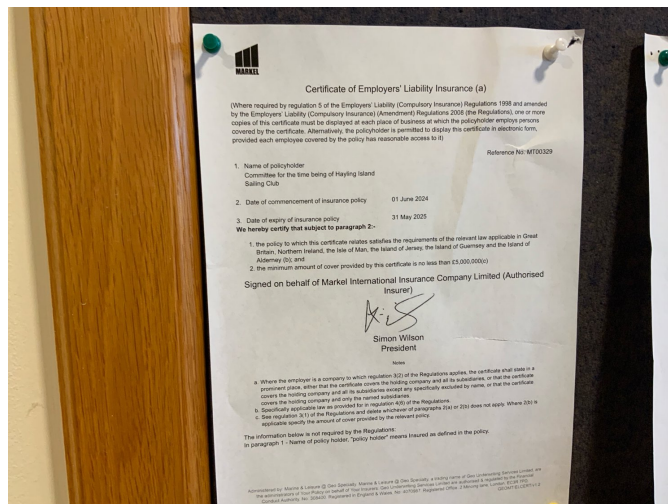
The Employers Liability Insurance Certificate is in date and prominently displayed within the premises. Documentary Evidence Seen - 28 May 2025 Please refer to image(s) under item 1.2 in the Photographs section.

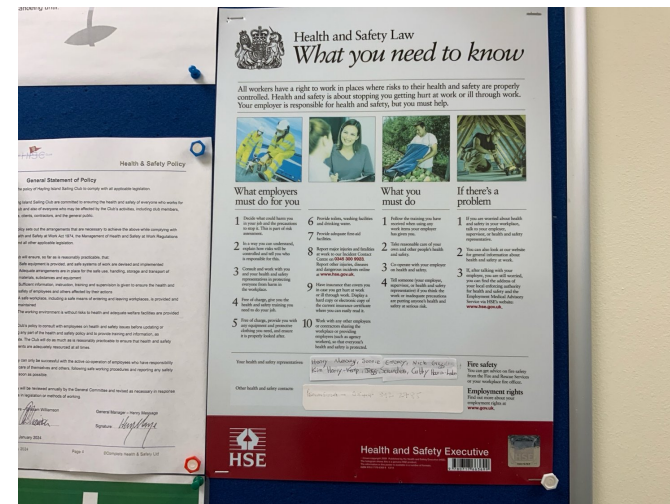
The Health and Safety poster "What You Need to Know" is prominently displayed within the premises where employees have access to the information. Please refer to image(s) under item 1.3 in the Photographs section.

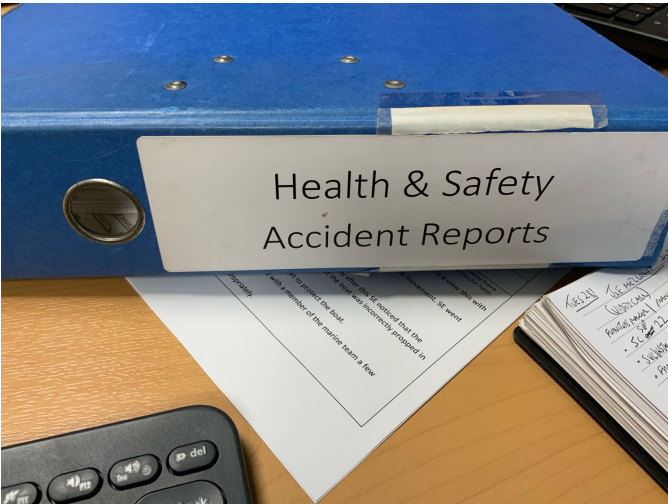
<p>Accidents are reported and recorded in a Data Protection compliant accident reporting system and accident investigations are completed as required to identify root causes and prevent similar occurrences. Well controlled accident reporting/recording system.</p> <p>Please refer to image(s) under item 1.11 in the Photographs section.</p>

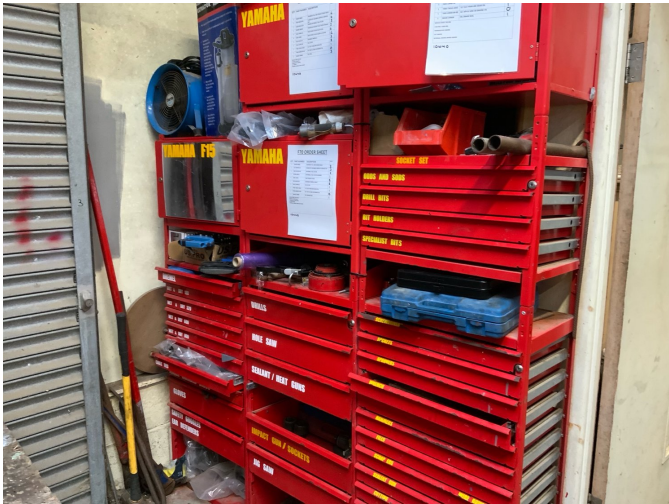
Suitable arrangements are in place with dedicated storage facilities provided. Please refer to image(s) under item 2.3 in the Photographs section.

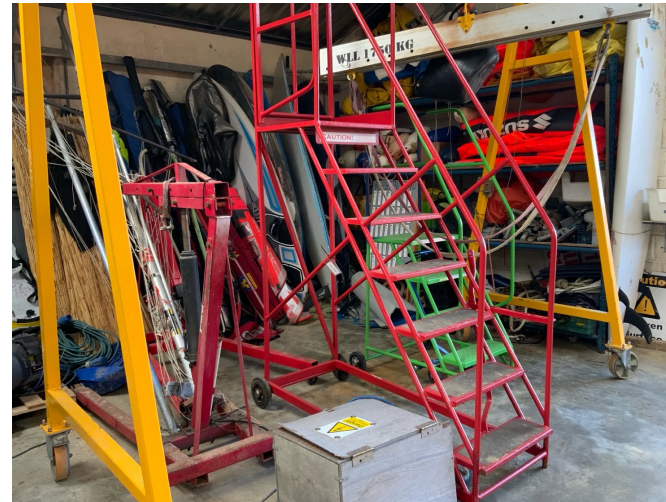
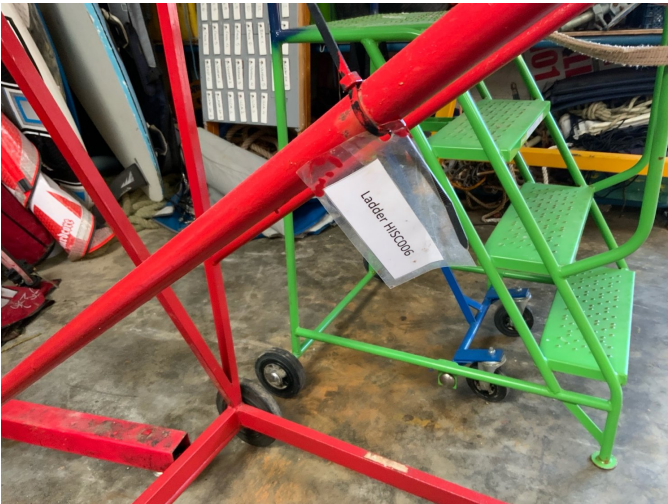
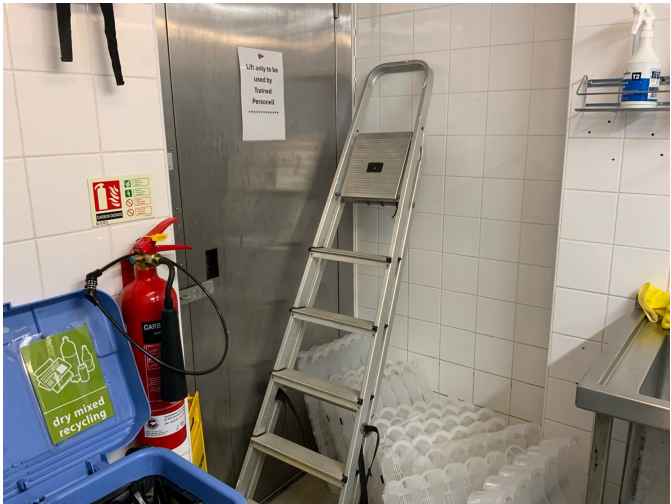
2.8	Work at height equipment including ladders, step ladders and aircraft ladders seen throughout the site. Minimal evidence was available to indicate that the access equipment is subject to a regular inspection regime. There were many ladders and access equipment seen throughout the site which requires rationalising. Please refer to image(s) under item 2.8 in the Photographs section.	Develop a register and succinct plant for access equipment checking. You should be aware of the current condition of access equipment and a suitable, recorded checking scheme should be in place. Each item of access equipment should be given an individual reference number and all work at height equipment is subject to a pre-use visual check of feet, locking mechanisms, condition of uprights and treads, etc.	4-21	Three months

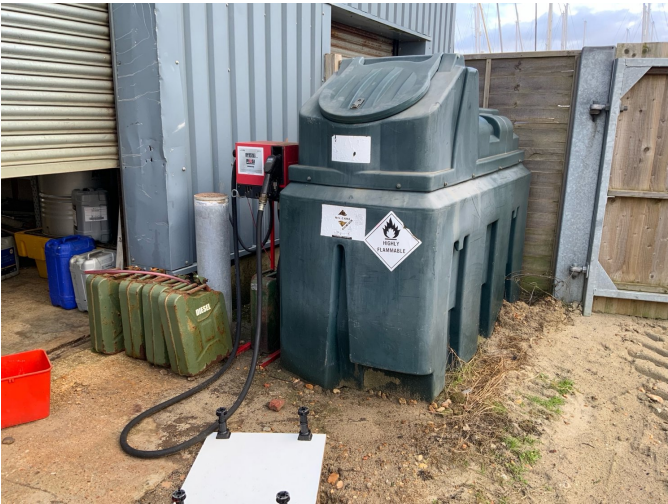
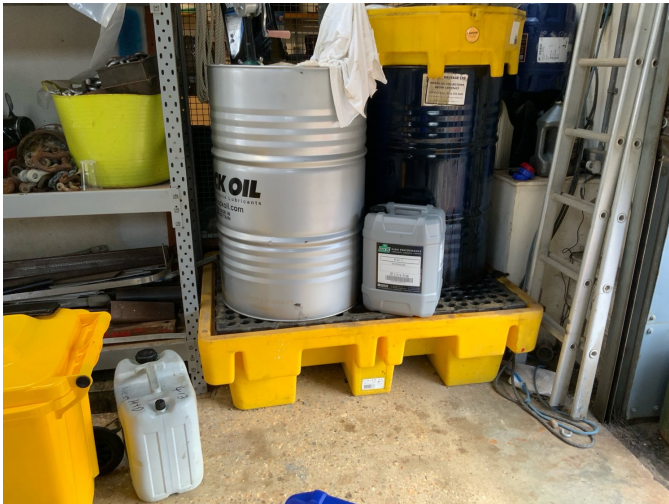
3.15	Are adequate arrangements in place to store and handle flammables?	 	Flammable substances are stored in a dedicated fire resistant facility away from direct sunlight and sources of ignition. The store is marked with the appropriate hazard identification sign(s). Please refer to image(s) under item 3.15 in the Photographs section.

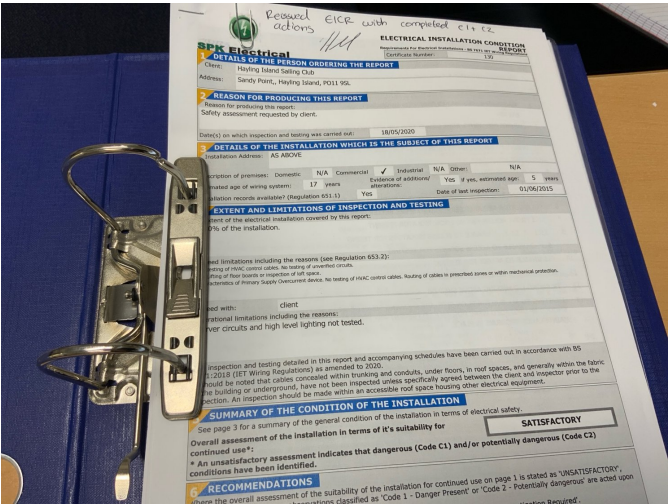
A hard wired electrical system test and inspection has been conducted by a suitably qualified electrical engineer within the prescribed timescale. The Condition Report reported the condition of the installation as "satisfactory". NEXT test due in May 2025 Please refer to image(s) under item 5.8 in the Photographs section.

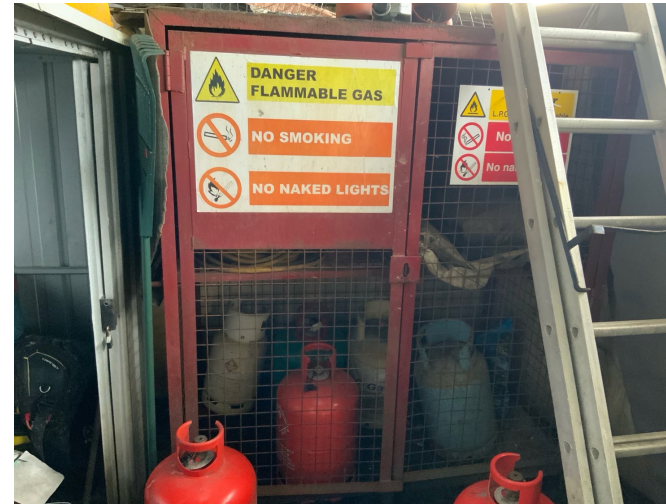
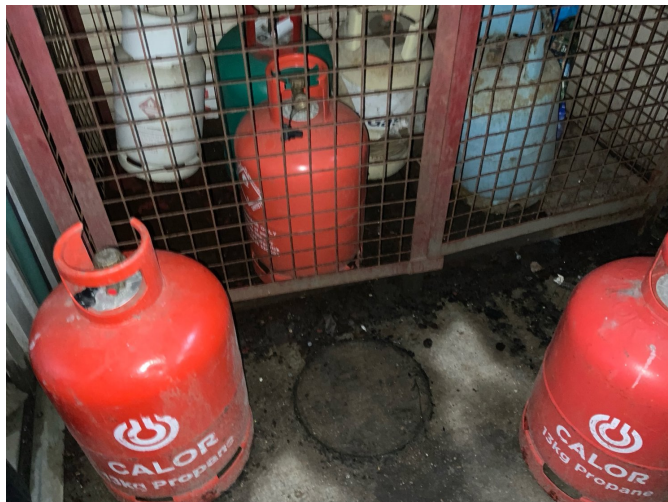
Ref.	Non-conformity and evidence	Action required	GN No	Agreed Timescale	Status	Allocated to	Completion Date (Initials)
5.24	Storage of gas bottles in yard area. Gas bottles stored on the ground rather than on suspended deck/platform/base - exposure to corrosion is increased which could jeopardise integrity of the gas bottles leading to release of contents. Please refer to image(s) under item 5.24 in the Photographs section.	Gas containers should be in a caged/secure area, away from ignition sources and raised from the ground to prevent corrosion. Install a cage floor to keep them raised from pooled rain water.	3-5	Six weeks

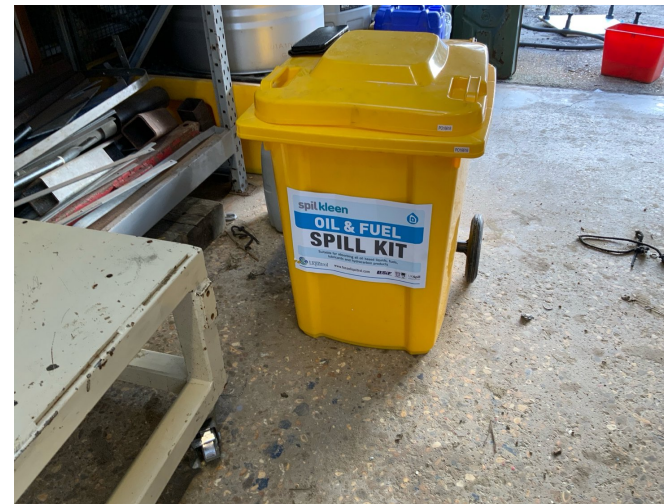
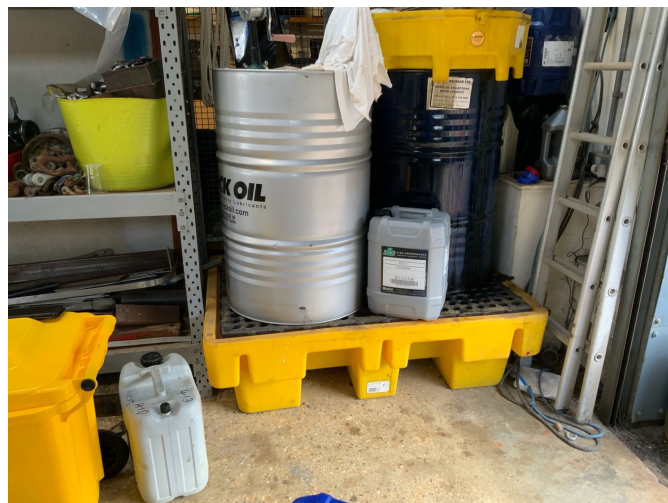
Adequate arrangements regarding hazardous and non hazardous waste are in place Please refer to image(s) under item 7.2 in the Photographs section.
